**Flood Control Project Maintenance
Levee Inspections**

Maintenance Issue Types Only, Levee Inspection Report By Mile - Spring 2018

Sutter Maintenance Yard East Levee Sacramento River

Waterway	Bank	Unit Miles	Inspection Start/End	Inspector
Unit No. 01 Sacramento River	Left	19.85	04/19/2018 04/19/2018	Bob Duffey

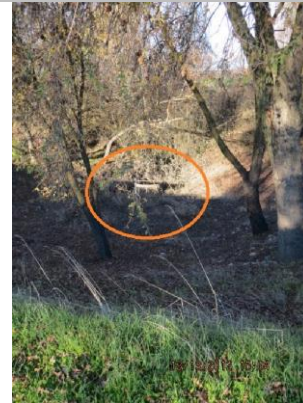
Photo 3 of 3 : UCIP_SP_2018_51650_46961.jpg

Landside view: overview

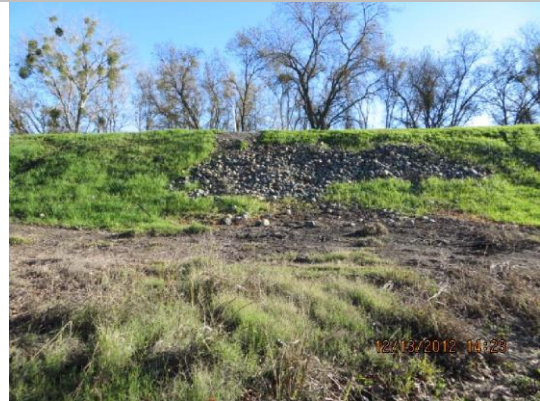
Photo 3 of 3 : UCIP_SP_2018_51655_46990.jpg

FS_ID:51655
DS_ID:17320
EP_NO: 9543
Repair Type: Urgent
Crossing Status: Found
UCIP Comments: 4/24/2017 WS was underwater during the site visit but I do not believe that any repairs have been made to this crossing yet. (DWR Sutter Yard- AFreitag)11/7/2016 No repairs have been made here yet. (DWR Sutter Yard- AFreitag)6/17/2016 River levels were down and the WS pipe end was exposed. WS end is completely rotten and damaged and flap gate has fallen off the end of the pipe (see pics). Pipe needs to be replaced or repaired. (DWR Sutter Yard - afreitag)4/5/2016 Erosion on WS slope still present. Pipe still fully submerged on WS and discharging into river during site visit. (DWR UCIP - kfazel)4/6/2015 Pipe leaks during high water. DWR employee said he suspects that the flap gate has rotted and fallen off WS end of pipe. Could not locate WS end of pipe to confirm. Water was flowing through this drain during field survey. (DWR Sutter Yard - afreitag)6/30/2014 Same as last inspection. (DWR Sutter Yard - afreitag)12/30/2013 Same as last inspection. (DWR Sutter Yard - afreitag)7/29/2013 Same as last inspection. (DWR Sutter Yard - afreitag) 12/13/2012 Water was flowing through this drain during field survey. (DWR UCIP - pamatya)

FIELD_STRUCT_DESC: 30-inch corrugated metal drainage pipe (at 45 degrees) through the levee, 25.2 feet below the crown. Flap gate on the waterside (WS), not found in 2016. (30-inch pipe [HLM 1.38] authorized under Automatic Board Order (ABO) issued as Permit No. 9543, 1974 - Harada). [Additional Reference(s): DWR Levee Log, 2002. USACE Sacramento O&M Manual 136, revision March 1960 (HLM 1.38)]
FS Date: 4/26/2017 9:57:29 AM

Landside view: overview of levee slope

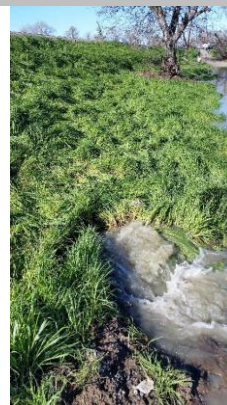
Photo 1 of 3 : UCIP_SP_2018_51665_76919.jpg

FS_ID:51665
DS_ID:17311
EP_NO: N/A
Repair Type: Urgent
Crossing Status: Found
UCIP Comments: 4/6/2017 Pipe was found in January 2017 during a high water event when water uncovered the buried WS end which led to uncontrolled water flow through during the high water event. The WS pipe opening was temporarily blocked off by plywood and sandbags until the pipe can be properly plugged or abandoned. Pics updated. (DWR Sutter Yard- A Freitag) 11/7/2016 Unable to locate. (DWR Sutter Yard- A Freitag) 6/6/2016 Unable to locate. 4/6/2015 Unable to locate. 6/30/2014 Unable to locate. 12/30/2013 Unable to locate. 7/29/2013 Same as last inspection. Unable to locate.
FIELD_STRUCT_DESC: *ABANDONED* 24-inch corrugated metal drainage pipe through the levee, 12.4 feet below the crown. Slide gate on the waterside (WS) end. Pipe silted over on both ends. (Automatic Board Order (ABO) issued as Permit No. 9539, 1974 - Locvich).

LS view of water exiting the pipe.

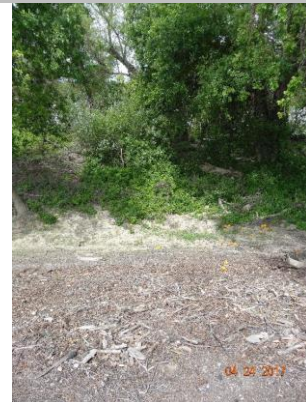
Photo 2 of 2 : UCIP_SP_2018_51666_77005.jpg

FS_ID:51666
DS_ID:17313
EP_NO: N/A
Repair Type: Non-Urgent
Crossing Status: Found
UCIP Comments: 4/24/2017 Slide gate structure found on WS about 10ft from levee toe. Vegetation was too thick to see if there were any more appurtances associated with this crossing visible on the WS. Nothing was visible on the LS. House located above pipe alignment at LS levee toe. Crossing appears abandoned and should be done so properly. (DWR Sutter Yard- A Freitag)11/7/2016 Unable to locate. (DWR Sutter Yard- A Freitag)6/6/2016 Unable to locate.4/6/2015 Unable to locate.6/30/2014 Unable to locate.12/30/2013 Unable to locate.7/29/2013 Same as last inspection. Unable to locate.
FIELD_STRUCT_DESC: *ABANDONED* 18-inch corrugated metal drainage pipe through the levee, 15 feet below the crown. Slide gate on the waterside (WS) end. [Additional Reference(s): DWR Levee Log, 2002. USACE Sacramento O&M Manual 136, March 1960 (HLM 3.6)].

View of WS from levee shoulder

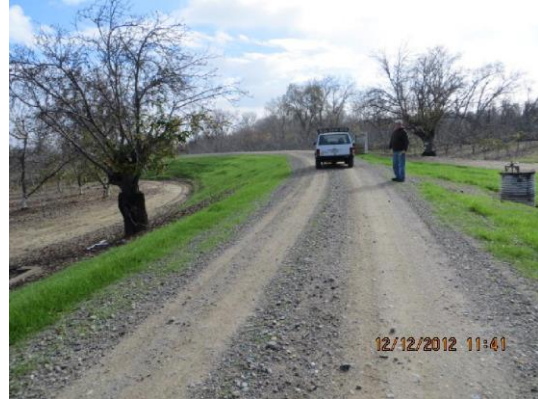
Photo 1 of 3 : UCIP_SP_2018_51698_47202.jpg

Crown view: overview (both sides of the levee)

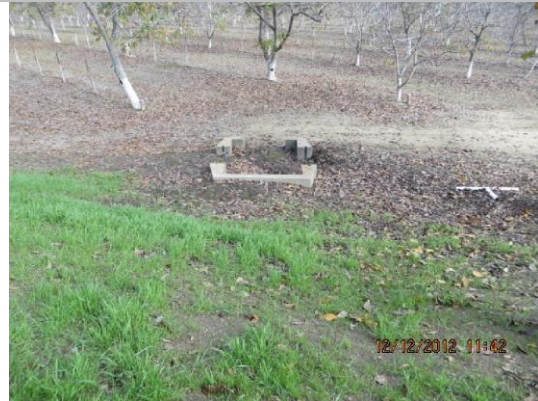
Photo 3 of 3 : UCIP_SP_2018_51698_47200.jpg

Landside view: overview of concrete box

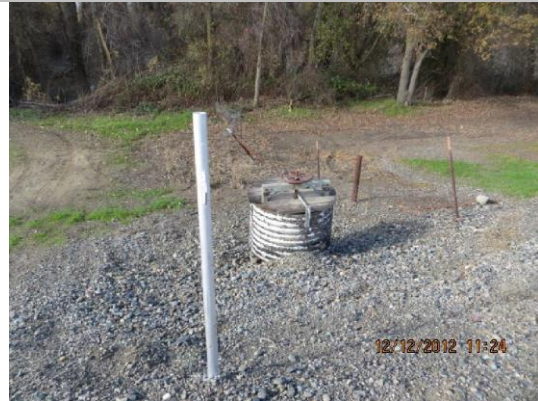
Photo 1 of 3 : UCIP_SP_2018_51725_47208.jpg

FIELD_STRUCT_DESC: *ABANDONED* 24-inch irrigation and drainage pipe through the levee, invert 11.5 feet below the crown. Slide gate in a corrugated metal pipe (CMP) riser on the waterside (WS) slope. (24-inch pipe [HLM 8.55] authorized under Automatic Board Order (ABO) issued as Permit No. 9529, 1974 - Dorwood Ranching Co.) [Additional Reference(s): DWR Levee Log, 2002. USACE Sacramento O&M Manual 136, March 1960 (HLM 8.55)]
FS Date: 5/1/2017 8:37:22 AM

Waterside view: overview of CMP riser

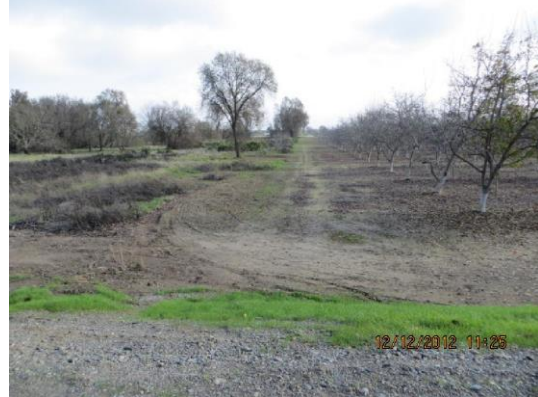
Photo 2 of 3 : UCIP_SP_2018_51725_47207.jpg

Landside view: overview (no pipes)

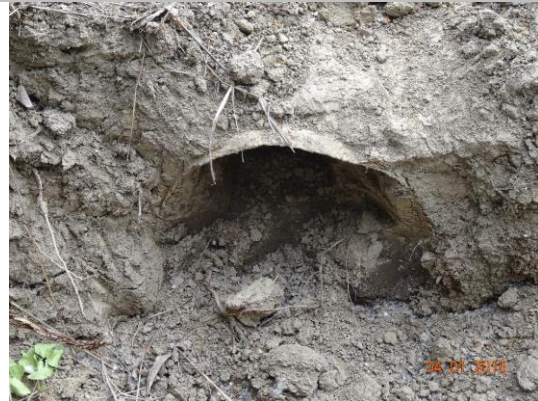
Photo 3 of 3 : UCIP_SP_2018_51725_73640.jpg

WS pipe end

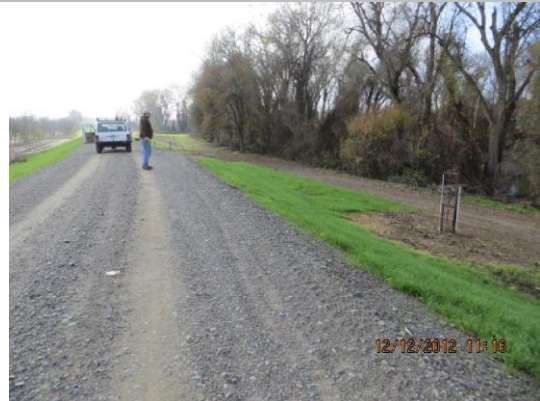
Photo 1 of 3 : UCIP_SP_2018_51726_47210.jpg

Waterside view: overview

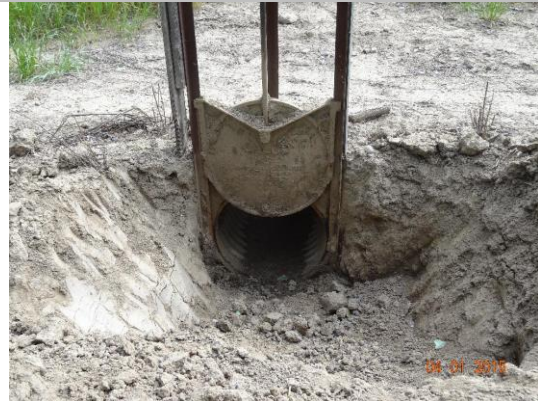
Photo 3 of 3 : UCIP_SP_2018_51726_73649.jpg

WS pipe end

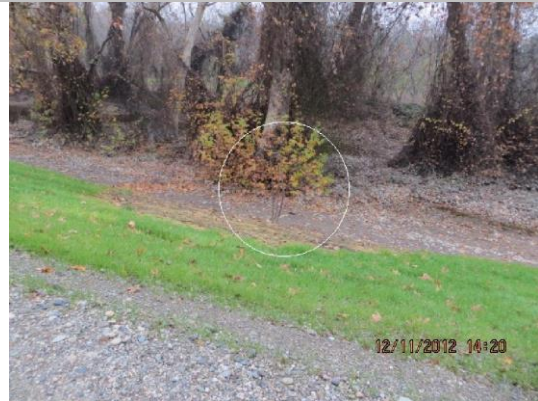
Photo 1 of 3 : UCIP_SP_2018_51729_47216.jpg

FIELD_STRUCT_DESC: 4-inch steel drainage pipe sleeved through 24-inch corrugated metal pipe through the levee, 16.7 feet below the crown. Annular space has been pressure grouted. Slide gate on the waterside (WS) end. Gate valve at the landside (LS) toe. (Permit No. 4491, 1964 - Blackmore). [Additional Reference(s): DWR Levee Log, 2002. USACE Sacramento O&M Manual 136, March 1960 (HLM 8.74)].
FS Date: 5/1/2017 9:06:02 AM

Waterside view: overview of slide gate on steel structure (belongs to crossing at CLM-8.782)

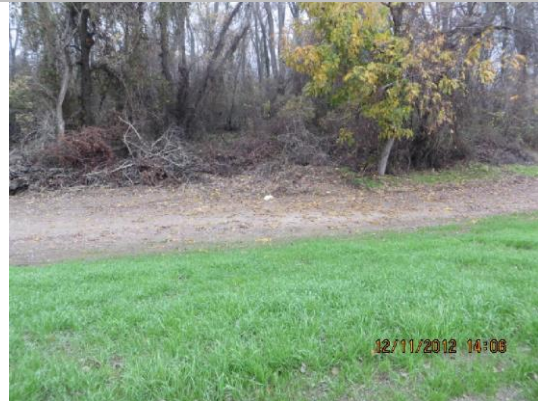
Photo 1 of 3 : UCIP_SP_2018_51731_47242.jpg

Waterside view: overview

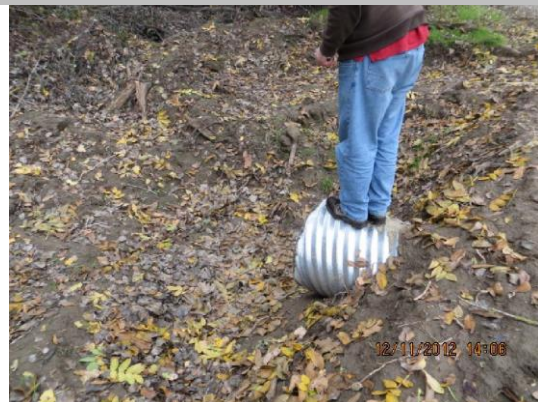
Photo 2 of 3 : UCIP_SP_2018_51731_47241.jpg

Waterside view: overview of CMP pipe

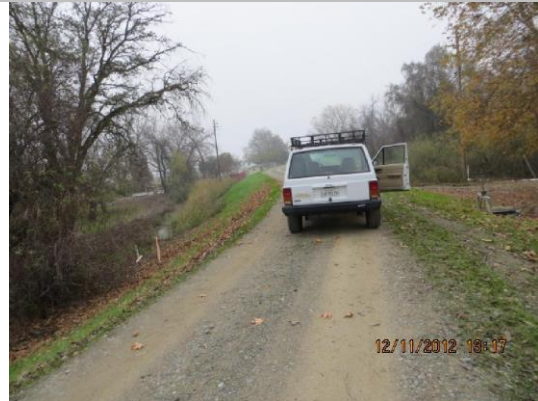
Photo 1 of 3 : UCIP_SP_2018_51734_47263.jpg

Crown view: overview (both sides of the levee)

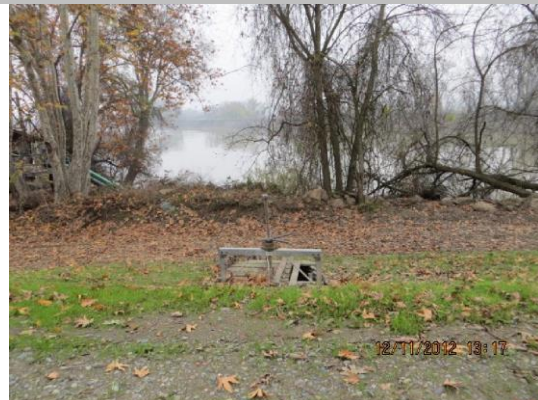
Photo 2 of 3 : UCIP_SP_2018_51734_47262.jpg

Waterside view: overview of CMP riser

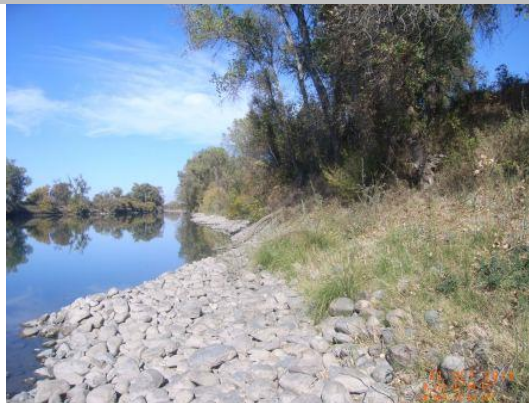
Photo 1 of 1 : SP_2018_ST0003_264_8_20180305_00007.jpg

LM Start	11.53	Rating **	M	Issue No.	8
LM End	11.79	Issue Type +	Ma	Location *	WS
Category	Supplemental			GPS Latitude/Longitude	
				Start	End
Item	2015 USACE Erosion Survey, DRAFT			39.279910 °	39.283853 °
				-122.018221 °	-122.016113 °
DWR ID	DWR_ST0003_01_s _ 2016_8				
Comment Code					
Inspector Comment					
2008 - Large rotational/mass failure in the bank with tree slump. 2009 - Minimal new erosion, the tree is leaning further into the river. 2011 - Site extended downstream. 2012 - Minor new erosion and tree roots are further exposed. 2015: Last observed in 2013. [2015 Site ID: SAC_152-6_L]

USACE 2013 Photo #1

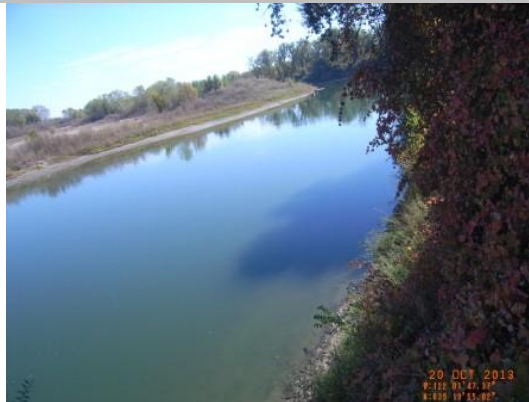
Photo 1 of 1 : SP_2018_ST0003_264_1_20180305_00001.jpg

LM Start	11.85	Rating **	M	Issue No.	1
LM End	11.90	Issue Type +	Ma	Location *	WS
Category	Supplemental			GPS Latitude/Longitude	
				Start	End
Item	2015 USACE Erosion Survey, DRAFT			39.331447 °	39.332716 °
				-122.029440 °	-122.029953 °
DWR ID	DWR_ST0003_01_s _ 2016_1				
Comment Code					
Inspector Comment					
2004 - Slowly eroding but near vertical with no vegetation to hold it.					
2005 - Erosion is close to levee toe but not into the levee section yet.					
2010 - Some new toe scour. 2015: Last observed in 2013. [2015 Site ID: SAC_157-7_R]

USACE 2013 Photo #1

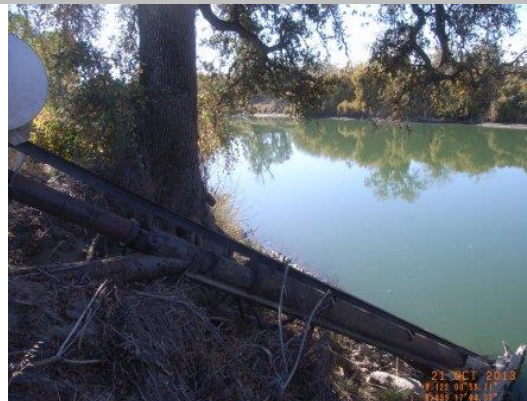
Photo 1 of 1 : SP_2018_ST0003_264_13_20180305_00011.jpg

LM Start	11.85	Rating **	M	Issue No.	13
LM End	11.90	Issue Type +	Ma	Location *	WS
Category	Supplemental			GPS Latitude/Longitude	
				Start	End
Item	2015 USACE Erosion Survey, DRAFT			39.284568 °	39.285298 °
				-122.015690 °	-122.015208 °
DWR ID	DWR_ST0003_01_s_2016_13				
Comment Code					
Inspector Comment					
2006 - Large rotational/mass failure in the bank with tree slump. Tough clayey toe material. 2007 - Site is between stone revetments with a pump station at the downstream end. 2010 - Erosion is into the levee toe. 2011 - Minor new erosion. 2012 - Minor new erosion. 2015: Last observed in 2013. [2015 Site ID: SAC_152-8_L]

USACE 2013 Photo #1

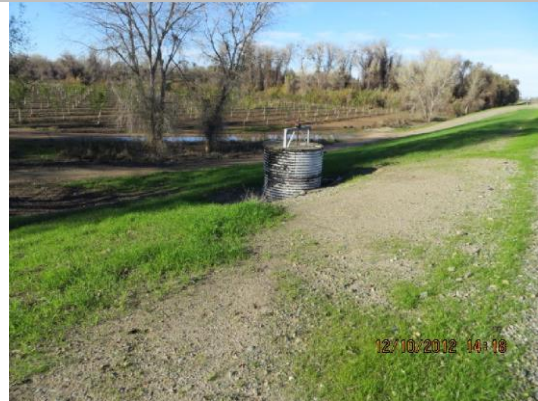
Photo 1 of 3 : UCIP_SP_2018_51749_47343.jpg

FIELD_STRUCT_DESC: *ABANDONED* 48-inch corrugated metal drainage pipe through the levee, 16.5 feet below the crown. Slide gate in a 60-inch corrugated metal pipe (CMP) riser on the waterside (WS) slope. Landside (LS) end of pipe on east side of River Road. Pipe is not in use but is operable. (48-inch pipe [HLM 13.37] authorized under Permit No. 9511, 1974 - Moresco). [Additional Reference(s): DWR Levee Log, 2002. USACE Sacramento O&M Manual 136, March 1960 (HLM 13.37)].
FS Date: 5/1/2017 10:27:34 AM

Waterside view: CMP riser with slide gate

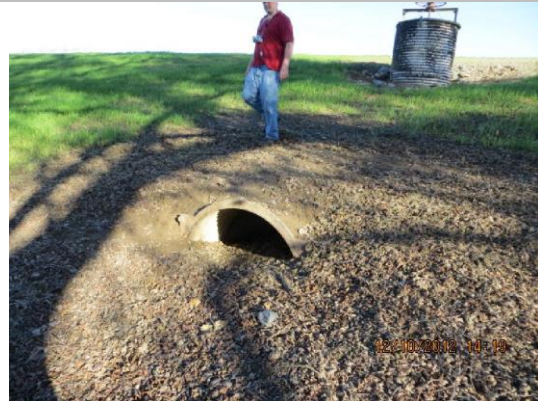
Photo 2 of 3 : UCIP_SP_2018_51749_47342.jpg

Waterside view: overview of CMP riser and outlet pipe

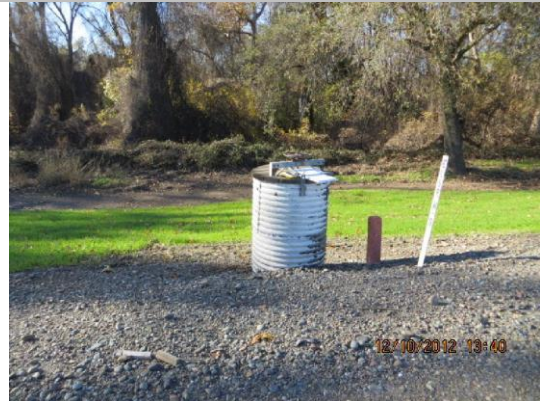
Photo 1 of 3 : UCIP_SP_2018_51752_47356.jpg

Waterside view: CMP riser with slide gate

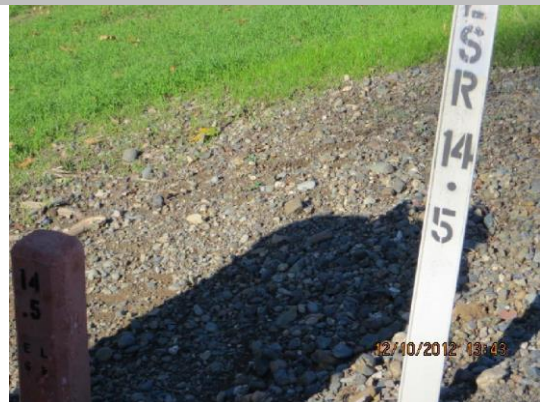
Photo 2 of 3 : UCIP_SP_2018_51752_47361.jpg

Waterside view: levee mile marker

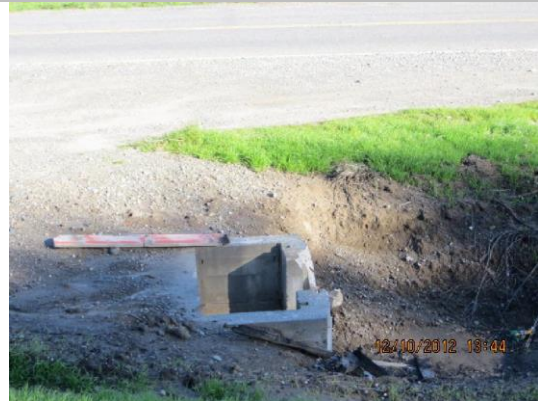
Photo 3 of 3 : UCIP_SP_2018_51752_47360.jpg

Landside view: overview of distribution box

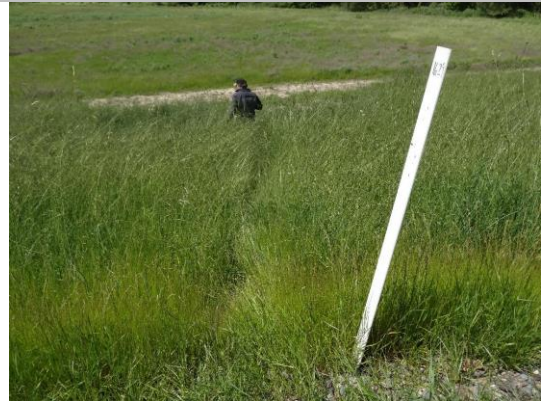
Photo 1 of 3 : UCIP_SP_2018_51759_75096.jpg

FS_ID:51759
DS_ID:17337
EP_NO: N/A
Repair Type: Non-Urgent
Crossing Status: Found
UCIP Comments: 4/20/2017 Abandoned- needs to be done so properly. (DWR Sutter Yard- A Freitag)11/1/2016 Abandoned. Pipe is buried and not visible but a white marker on WS shoulder shows its location. (DWR Sutter Yard- A Freitag)6/15/2016 Pipe was dug up and internally cleaned and camera inspected on 11/19/2015 by Nor-Cal Pipeline Services. Pipe section through the levee is 88ft long and showed signs of rusting but no holes or other deterioration was found. The WS flap gate was broken during excavation but doesn't pose an issue as the pipe was capped and reburied until further abandonment can be achieved. Unfortunately the pipe was not photographed when exposed.4/14/2016 Same as last inspection.4/2/2015 Unable to locate. Pipe has been selected to be dug up and internally camera inspected.7/2/2014 Unable to locate.12/19/2013 Unable to locate7/23/2013 Same as last inspection. Unable to locate.

View from crown down WS slope at location of crossing.

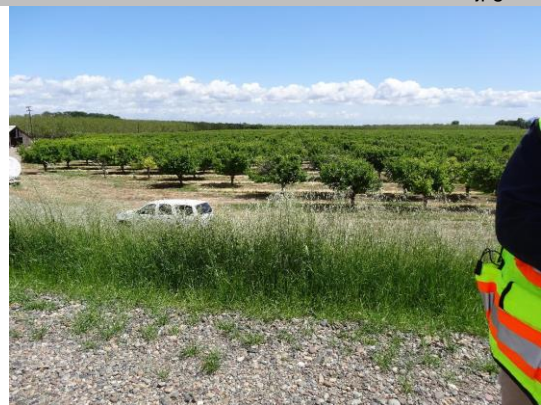
Photo 2 of 3 : UCIP_SP_2018_51759_75097.jpg

View of LS from crown at location of crossing.

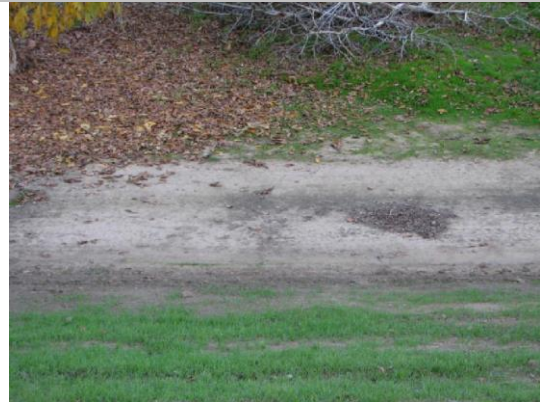
Photo 1 of 3 : UCIP_SP_2018_51762_47384.jpg

FS_ID:51762
DS_ID:17329
EP_NO: N/A
Repair Type: Non-Urgent
Crossing Status: Found
UCIP Comments: 4/20/2017 Abandoned- needs to be done properly.
Pipe had a small leak during high water and is believed to be caused by the screw gate not being fully closed before it was reburied after its internal inspection. (DWR Sutter Yard- A Freitag) 11/1/2016
Abandoned. (DWR Sutter Yard- A Freitag) 6/15/2016 Pipe was dug up and internally cleaned and camera inspected on 11/18/2015 by Nor-Cal Pipeline Services. Pipe section through levee is about 93.8ft long. Inspection showed signs of rusting but no holes or other deterioration was found. WS end and slidegate were photographed, LS end was not. After the inspection pipe ends were capped and reburied until further abandonment can be achieved. 4/2/2015 WS pipe end was dug up in preparation for internal camera inspection. Only steel slide gate structure found on waterside. 7/2/2014 Same as last inspection. 12/19/2013 Same as last inspection. 7/24/2013 Same as last inspection.

FIELD_STRUCT_DESC: *ABANDONED* 24-inch corrugated metal drainage pipe through the levee, 15.8 feet below the crown. Slide gate on the waterside (WS) end. Both pipe ends are silted over. [Additional Reference(s): DWR Levee Log, 2002. USACE Sacramento O&M Manual 136, March 1960 (HLM 17.6)].
FS Date: 5/1/2017 10:45:36 AM

Landside view: overview. No pipe found.

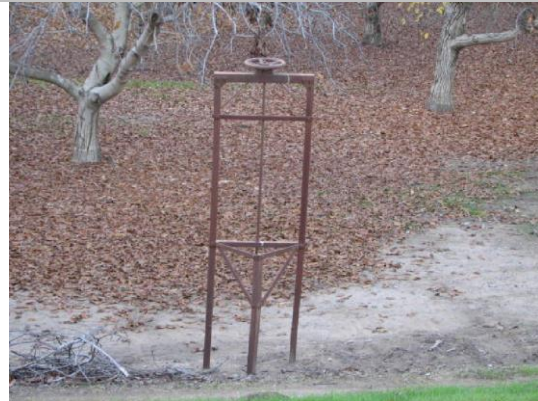
Photo 2 of 3 : UCIP_SP_2018_51762_47386.jpg

FS_ID:51762
DS_ID:17329
EP_NO: N/A
Repair Type: Non-Urgent
Crossing Status: Found
UCIP Comments: 4/20/2017 Abandoned- needs to be done properly. Pipe had a small leak during high water and is believed to be caused by the screw gate not being fully closed before it was reburied after its internal inspection. (DWR Sutter Yard- A Freitag)11/1/2016 Abandoned. (DWR Sutter Yard- A Freitag)6/15/2016 Pipe was dug up and internally cleaned and camera inspected on 11/18/2015 by Nor-Cal Pipeline Services. Pipe section through levee is about 93.8ft long. Inspection showed signs of rusting but no holes or other deterioration was found. WS end and slidegate were photographed, LS end was not. After the inspection pipe ends were capped and reburied until further abandonment can be achieved.4/2/2015 WS pipe end was dug up in preparation for internal camera inspection. Only steel slide gate structure found on waterside.7/2/2014 Same as last inspection.12/19/2013 Same as last inspection.7/24/2013 Same as last inspection.

Waterside view: slide gate steel structure

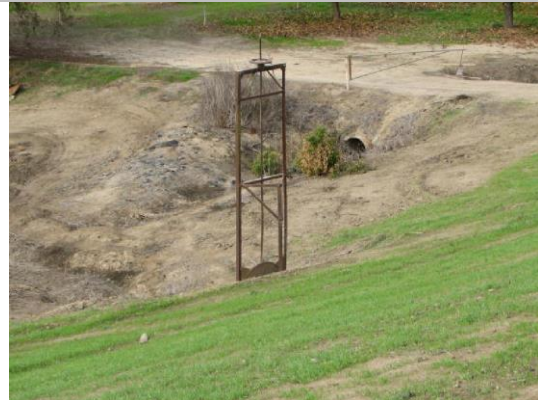
Photo 1 of 3 : UCIP_SP_2018_51770_47399.jpg

FS_ID:51770
DS_ID:17345
EP_NO: N/A
Repair Type: No Action Needed
Crossing Status: Found
UCIP Comments: 4/20/2017 Crossing appears to be in good condition. (DWR Sutter Yard- AFreitag)11/1/2016 Crossing appears to be in good condition. (DWR Sutter Yard- AFreitag)6/16/2016 Pipe was internally cleaned and camera inspected on 11/19/2015 by Nor-Cal Pipeline Services. Pipe is 155ft in total length and the inspection showed some minor rusting but no holes or other deformations were found. Pipe is still used by the landowner for irrigation and the sloughing near the WS end was repaired and rocked to prevent future sloughing or erosion.4/14/2016 Sloughing repaired by Sutter Yard with rock revetment.4/2/2015 Same as last inspection. Pipe has been selected for internal camera inspection.Sloughing at outlet and levee slope is damaged due to sloughing.7/2/2014 It is not an abandoned crossing. Sloughing at outlet and levee slope is damaged due to sloughing.12/19/2013 Same as last inspection.7/24/2013 Same as last inspection.

Waterside view: overview of sliding gate structure

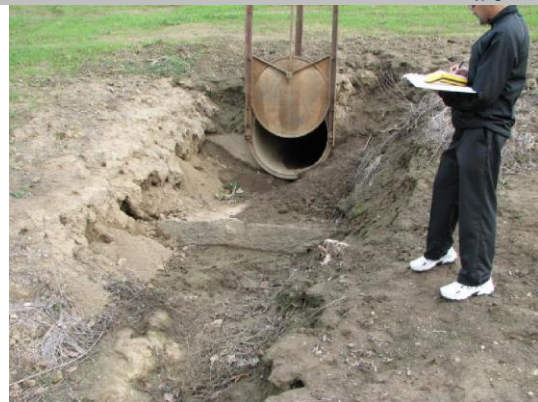
Photo 2 of 3 : UCIP_SP_2018_51770_47398.jpg

Waterside view: outlet pipe with concrete headwall and floor apron.

FS_ID:51770
DS_ID:17345
EP_NO: N/A
Repair Type: No Action Needed
Crossing Status: Found
UCIP Comments: 4/20/2017 Crossing appears to be in good condition. (DWR Sutter Yard- AFreitag)11/1/2016 Crossing appears to be in good condition. (DWR Sutter Yard- AFreitag)6/16/2016 Pipe was internally cleaned and camera inspected on 11/19/2015 by Nor-Cal Pipeline Services. Pipe is 155ft in total length and the inspection showed some minor rusting but no holes or other deformations were found. Pipe is still used by the landowner for irrigation and the sloughing near the WS end was repaired and rocked to prevent future sloughing or erosion.4/14/2016 Sloughing repaired by Sutter Yard with rock revetment.4/2/2015 Same as last inspection. Pipe has been selected for internal camera inspection.Sloughing at outlet and levee slope is damaged due to sloughing.7/2/2014 It is not an abandoned crossing. Sloughing at outlet and levee slope is damaged due to sloughing.12/19/2013 Same as last inspection.7/24/2013 Same as last inspection.

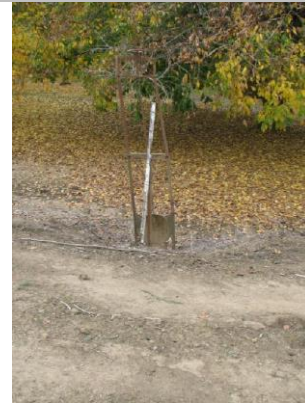
Photo 1 of 3 : UCIP_SP_2018_51771_47442.jpg

FS_ID:51771
DS_ID:17346
EP_NO: 9503
Repair Type: No Action Needed
Crossing Status: Found
UCIP Comments: 4/20/2017 Crossing appears to be in good condition. (DWR Sutter Yard- AFreitag)11/1/2016 Crossing appears to be in good condition. (DWR Sutter Yard- AFreitag)6/16/2016 Pipe was internally cleaned and camera inspected on 11/19/2015 by Nor-Cal Pipeline Services. 129.5 ft (starting from the WS end) was inspected to get get us through the levee prism but the LS end was never found. Pipe showed no signs of rust or damage.4/14/2016 Inlet structure still filled with soil.4/2/2015 Same as last inspection. Pipe has been selected for internal camera inspection.According to local people, the crossing is functional. The gap between 8-inch and 24-inch pipes is grouted with cement. Inlet structure is filled with soil.7/2/2014 Same as last inspection.12/19/2013 Same as last inspection.7/24/2013 Same as last inspection.

FIELD_STRUCT_DESC: 24-inch corrugated metal drainage pipe through the levee, 19 feet below the crown. 8-inch steel pipe sleeved through the 24-inch pipe. Annular space cement grouted. Slide gate at the waterside (WS) toe. Concrete inlet box on the landside (LS). (24-inch pipe [HLM 18.74] authorized under Automatic Board Order (ABO) issued as Permit No. 9503, 1974 - Baird). [Additional Reference(s): DWR Levee Log, 2002. USACE Sacramento O&M Manual 136, March 1960 (HLM 18.74)].
FS Date: 5/1/2017 10:53:44 AM

Waterside view: overview of slide gate structure

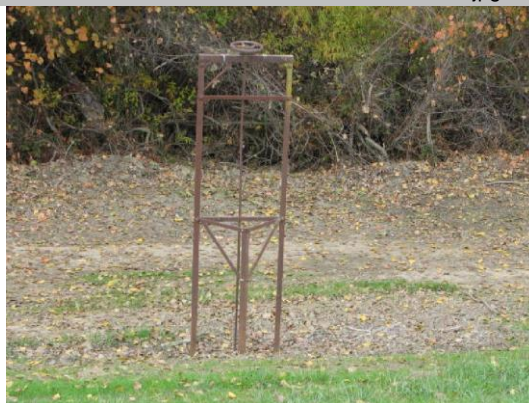
Photo 1 of 3 : UCIP_SP_2018_51773_47447.jpg

FS_ID:51773
DS_ID:17347
EP_NO: N/A
Repair Type: No Action Needed
Crossing Status: Found
UCIP Comments: 4/20/2017 Abandoned- plugged. (DWR Sutter Yard-AFreitag)11/1/2016 Abandoned/plugged. (DWR Sutter Yard-AFreitag)6/16/2016 Internal camera inspection was done on 11/19/2015 by Nor-Cal Pipeline Servies. Pipe was inspected starting from the WS end and inspected upto the grout plug that is 13.7ft into the pipe. Pipe was then capped and reburied until further abandonment can be achieved.4/2/2015 WS end of pipe was dug up in preparation for internal camera inspection. Only steel slide gate structure found on WS.7/2/2014 Same as last inspection.12/19/2013 Same as last inspection.7/24/2013 Same as last inspection.
FIELD_STRUCT_DESC: *ABANDONED* 36-inch corrugated metal drainage pipe through the levee, 21.7 feet below the crown. Slide gate at the waterside (WS) toe. Pipe grouted on the WS end. [Additional Reference(s): DWR Levee Log, 2002. USACE Sacramento O&M Manual 136, March 1960 (HLM 19.24)].

Waterside view: overview of abandoned slide gate structure

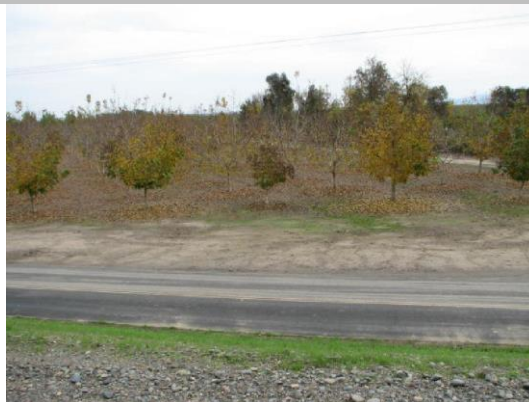
Photo 2 of 3 : UCIP_SP_2018_51773_47446.jpg

Landside view: overview (no pipes)

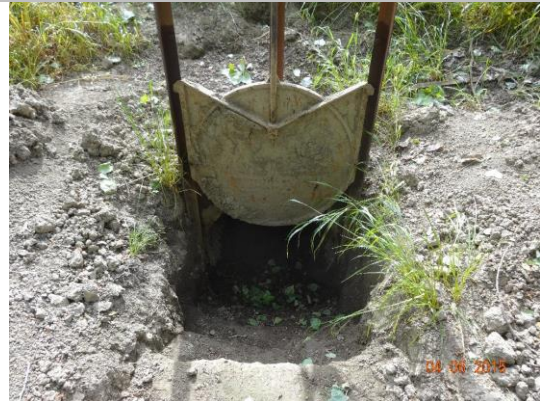
Photo 3 of 3 : UCIP_SP_2018_51773_73781.jpg

FS_ID:51773
DS_ID:17347
EP_NO: N/A
Repair Type: No Action Needed
Crossing Status: Found
UCIP Comments: 4/20/2017 Abandoned- plugged. (DWR Sutter Yard-AFreitag)11/1/2016 Abandoned/plugged. (DWR Sutter Yard-AFreitag)6/16/2016 Internal camera inspection was done on 11/19/2015 by Nor-Cal Pipeline Servies. Pipe was inspected starting from the WS end and inspected upto the grout plug that is 13.7ft into the pipe. Pipe was then capped and reburied until further abandonment can be achieved.4/2/2015 WS end of pipe was dug up in preparation for internal camera inspection. Only steel slide gate structure found on WS.7/2/2014 Same as last inspection.12/19/2013 Same as last inspection.7/24/2013 Same as last inspection.
FIELD_STRUCT_DESC: *ABANDONED* 36-inch corrugated metal drainage pipe through the levee, 21.7 feet below the crown. Slide gate at the waterside (WS) toe. Pipe grouted on the WS end. [Additional Reference(s): DWR Levee Log, 2002. USACE Sacramento O&M Manual 136, March 1960 (HLM 19.24)].

WS pipe end and screw gate

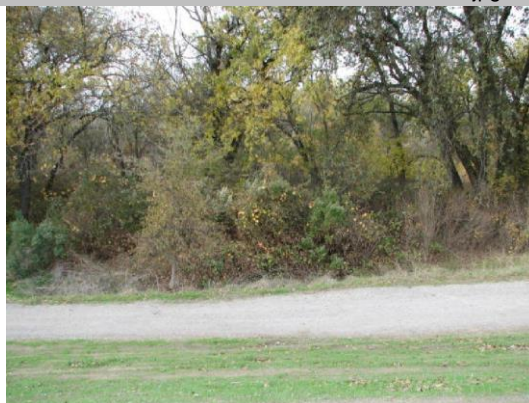
Photo 1 of 3 : UCIP_SP_2018_51775_47449.jpg

FS_ID:51775
DS_ID:17487
EP_NO: N/A
Repair Type: Non-Urgent
Crossing Status: Found
UCIP Comments: 4/20/2017 Abandoned- needs to be done so properly. (DWR Sutter Yard- A Freitag) 11/1/2016 Abandoned. (DWR Sutter Yard- A Freitag) 6/3/2016 Abandoned crossing. 4/2/2015 Same as last inspection. Slide Gate WS not found. An abandoned pump and steel pipe found on WS. A 6 ft x 8 ft concrete distribution box with a CMP found on LS. Box filled with soil. An abandoned crossing. 7/2/2014 Same as last inspection. 12/19/2013 Same as last inspection. 7/24/2013 Same as last inspection.
FIELD_STRUCT_DESC: *ABANDONED* 36-inch corrugated metal drainage pipe through the levee, invert 21.7 feet below the crown. Abandoned pump and steel pipe found on the waterside (WS). 6 foot by 8 foot concrete distribution box with the 36-inch corrugated metal pipe found on the landside (LS). [Additional Reference(s): USACE Sacramento O&M Manual 136, March 1960 (HLM 19.61)].

Waterside view: overview

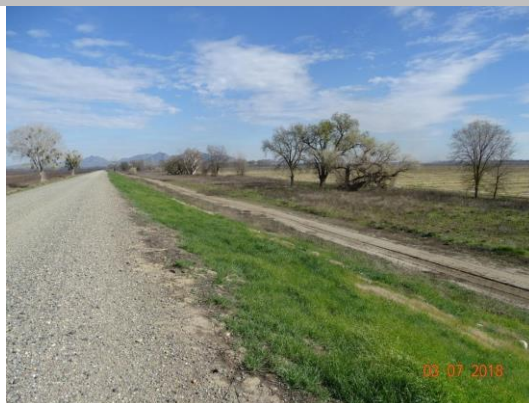
Photo 1 of 1 : SP_2018_ST0003_265_3_20180312_00005.jpg

LM Start	0.41	Rating **	A	Issue No.	3
LM End	0.41	Issue Type +	Ma	Location *	LS
Category	Earthen Levee			GPS Latitude/Longitude	
				Start	End
Item	Vegetation			39.231423 °	39.231423 °
				-121.988438 °	-121.988438 °
DWR ID	DWR_ST0003_02_s_2018_3				
Comment Code					
V1 : Control annual grass and weeds on the levee slopes and easements.					
Inspector Comment					
Native grasses on both slopes are adequately maintained.

View of native grasses on both slopes.

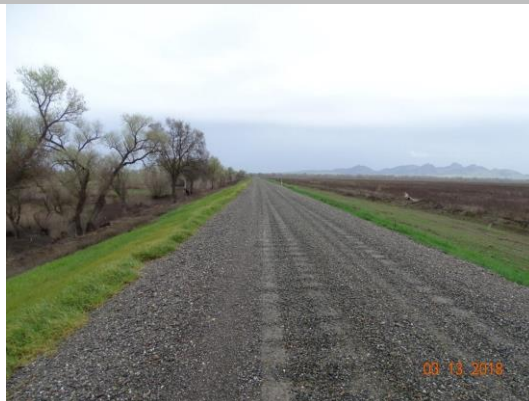
Photo 1 of 1 : SP_2018_ST0003_266_1_20180402_00007.jpg

LM Start	0.48	Rating **	A	Issue No.	1
LM End	0.48	Issue Type +	Ma	Location *	LS
Category	Earthen Levee			GPS Latitude/Longitude	
				Start	End
Item	Vegetation			39.236988 °	39.236988 °
				-121.985390 °	-121.985390 °
DWR ID	DWR_ST0003_03_s_2018_1				
Comment Code					
V1 : Control annual grass and weeds on the levee slopes and easements.					
Inspector Comment					
LMA should continue to maintain native grasses on both slopes.

View of the native grasses on both slopes.
